Installation of the CHIP in the toner cartridge for Lexmark™ Optra™ T/Se

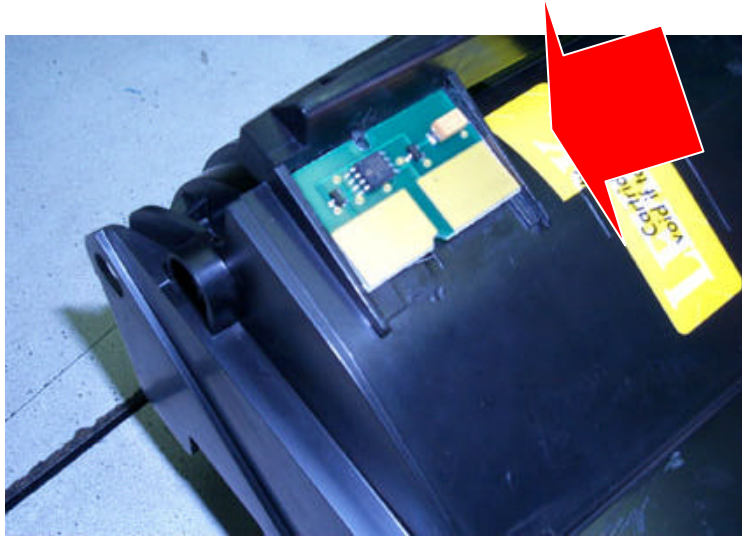
1. Remove the adhesive protection and press the sticky face against the plastic to ensure that the chip is properly attached.
